## **ALIWAL NORTH LANDFILL SITE**

Geotechnical Investigations Report Conducted for the Proposed Aliwal North Landfill Site, Aliwal North, Eastern Cape.

Report Number: BCS-23-0005

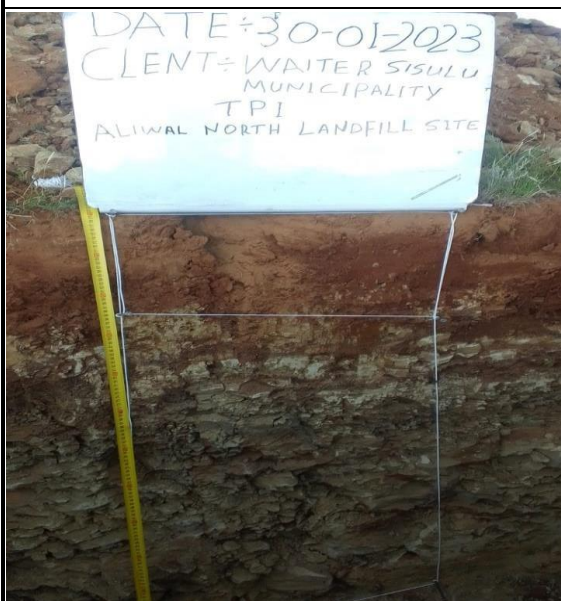
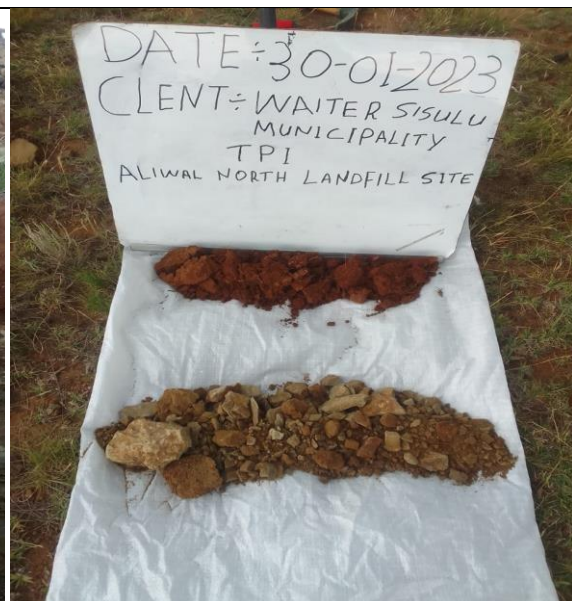
End Depth: 1450mm

The upper soil layer found across the site is comprised of an undifferentiated topsoil of hillwash materials defined as a slightly moist to moist, dark reddish brown, loose to medium dense, fine to coarse-grained, intact, Silty Clayey SAND (and sometimes with gravelly intercalations). This material layer is intercepted from the existing ground surface to a maximum depth of 450 mm (below the existing ground level).

The residual soil layer found on site is defined as a dry to slightly moist, dark brownish grey, very dense to hard, intact Sandy GRAVEL (after a decomposed dolerite). Immediately below the residual soil layer is a moist, pale, greenish to reddish brown, hard bedrock of a decomposed dolerite.

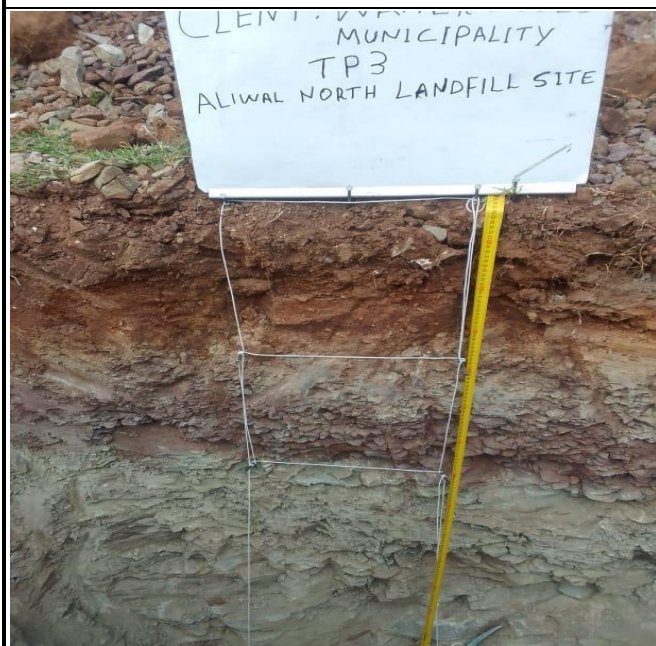
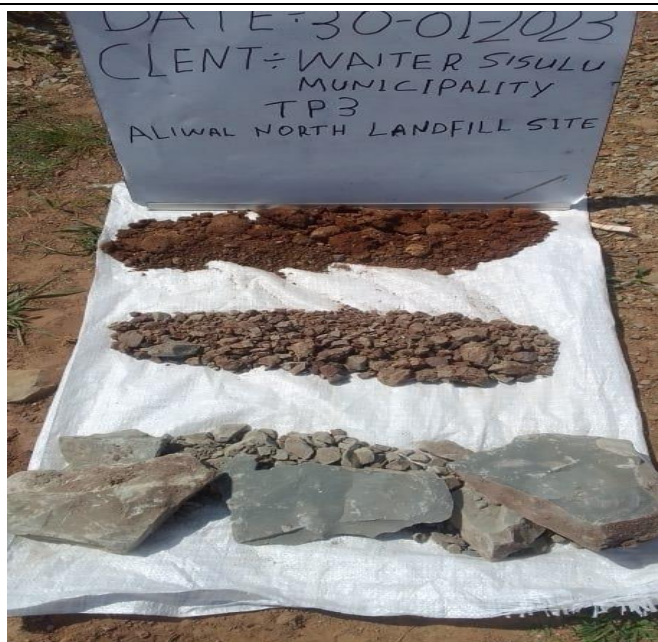
End Depth: 1700mm

The second layer found on site is comprised of reworked residual soils and is defined as a slightly moist, purplish to reddish brown, medium dense, intact, Silty Sandy GRAVEL (after a decomposed dolerite). This material was intercepted at a single site (TP03) between the depth of 400 to 700 mm (below the existing ground level).
