## **ALIWAL NORTH – PROPOSED LANDFILL SITE**

Geotechnical Investigations Report: Proposed Aliwal North Landfill Site, Aliwal North, Eastern Cape.

Report Number: BCS-24-0029

The Walter Sisulu Local Municipality.

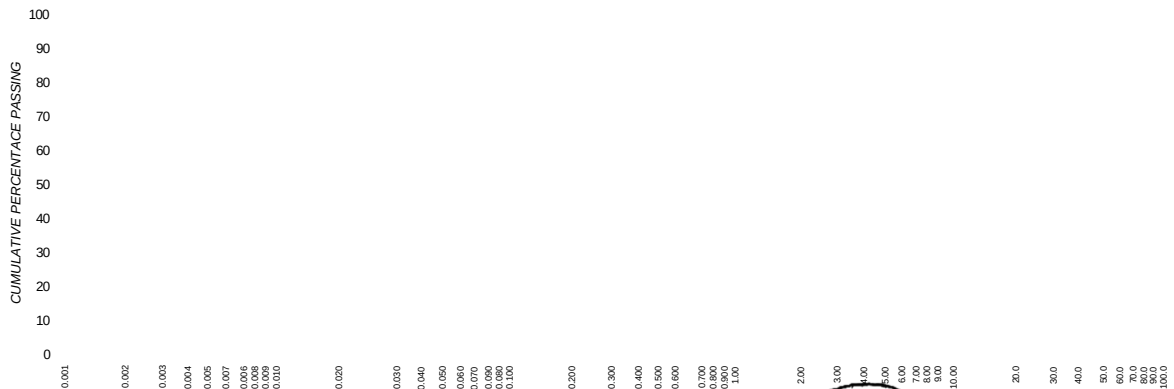
SAMPLE DESCRIPTION : DARK  
Clayey Silty Sand

## FOUNDATION INDICATOR - (SANS 3001-GR1, SANS 3001-GR10) & (ASTM Method D422)

| CLAY (%) (0.001-0.002) | SILT (%) (0.002-0.060) | SAND (%) (0.060-2.00) | GRAVEL (%) (2.00-60.0) |
| 11.7 | 20.8 | 67.4 | 0.0 |

Disturbed soil samples, considered to be representative of the materials on site were subjected to road indicator testing (as per SANS 3001 test methods). Foundation Indicator tests to determine the to determine the soil grading, Atterberg limits and potential expansiveness of the founding soils. The grain size analysis is widely used in classification of materials and determination of the engineering behaviour of materials. The distribution of different grain sizes affects the engineering properties of materials. Grain size analysis provides the grain size distribution, and it is required in classifying the material. Particle size grading of the soils or sieve analysis is the easiest way to describe the relative amounts of gravel, sand, silt, and clay within the soil. A summary of the foundation indicator test results is shown in Table 6.2 \_1 whilst detailed test results are depicted in Appendix C attached to this Report.

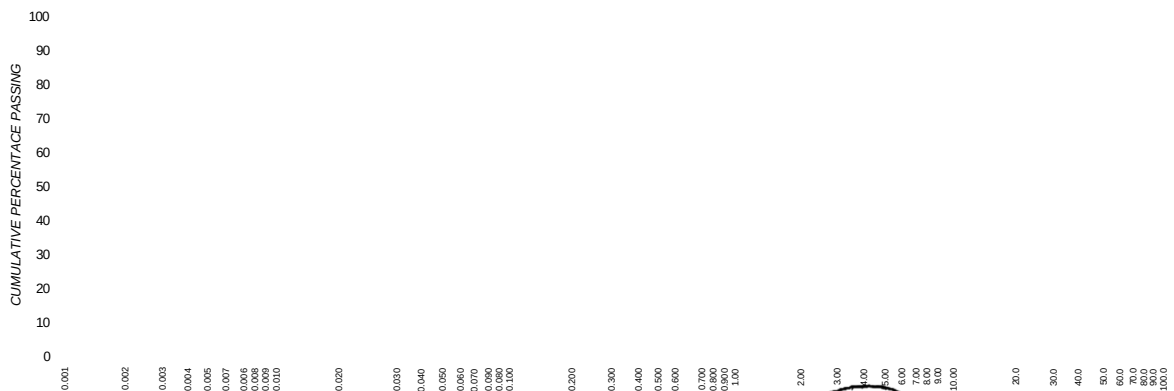
DATE RECEIVED : 16/09/2024  
POSITION : TP 02  
LAYER : 0.880 - 3.000  
SAMPLE No. : RT 484

**SAMPLE DESCRIPTION :** BROWN  
Silty Sand

| U.S. Highway Classification | A-4 (0) |

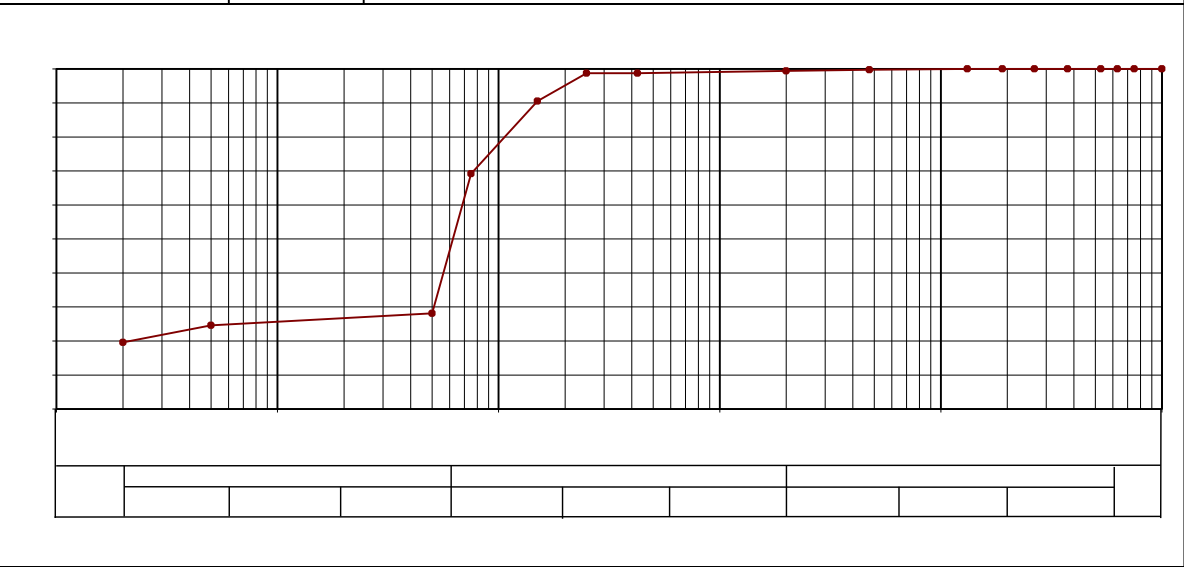
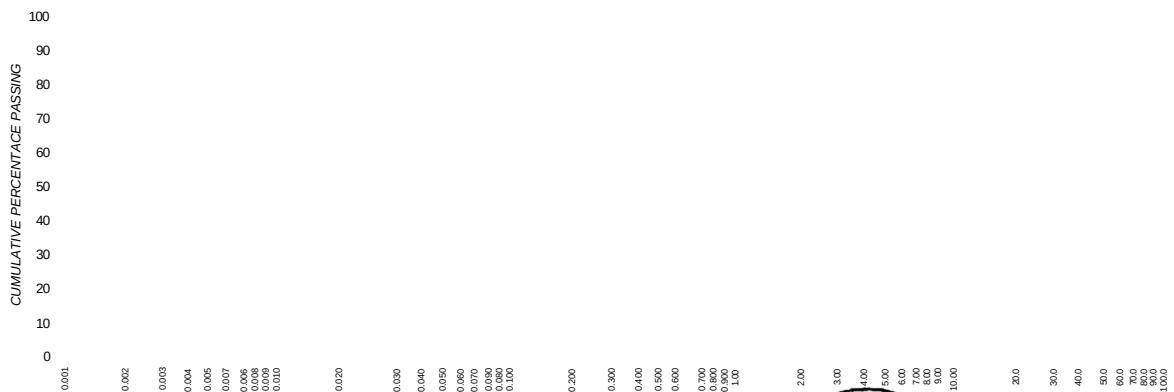
**DATE RECEIVED :** 16/09/2024  
**POSITION :** TP 03  
**LAYER :** 2.800 - 3.000  
**SAMPLE No. :** RT 486  
**LE DESCRIPTION :** BROWN WHITE  
 Silty Clayey Sand

**Weighted PI** 9.2

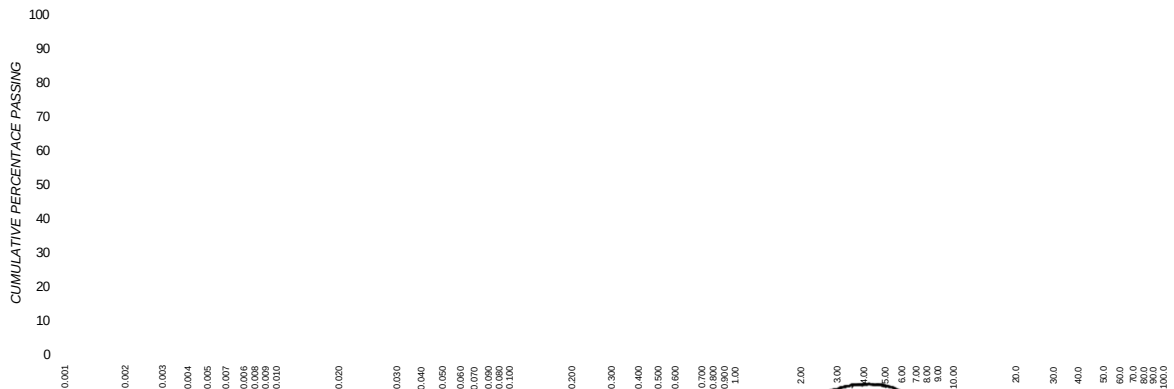
DATE RECEIVED : 16/09/2024  
POSITION : TP 05  
LAYER : 0.0 - 0.600  
SAMPLE No. : RT 487  
LE DESCRIPTION : DARK BROWN  
Silty Clayey Sand

| Weighted PI | 6.0 |
